Deputy Inspector Grzegorz Bogiel, M.Sc., Eng.
Central Forensic Laboratory of the Police

Customized weapons identification tests

The article raises the issue of individual weapons identification tests which can be performed, including when it is not possible to fire shots in order to obtain comparative material. The article describes one of such cases, involving bursting of the cartridge chamber of a shotgun during the shooting.

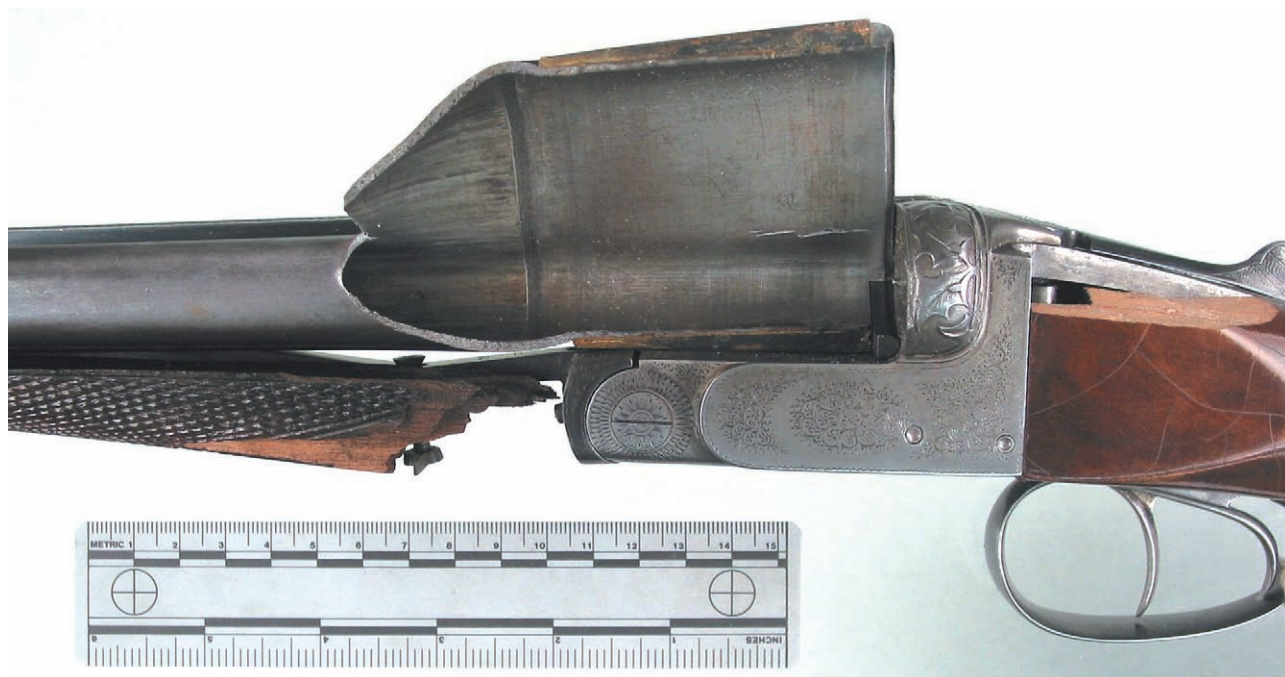
Fig. 1. Left side view of the shotgun.

The examination started with a visual inspection of the weapon. A rupture was visible on the left side of the barrel. The outer surface of the barrel near the beginning of the rupture – about 115 mm from the barrel inlet – was slightly bulged, which indicates that in this particular position, the pressure inside the barrel exceeded the value corresponding to the permissible elastic limit of steel. As a result, the barrel material has been plastically deformed – the bulge mentioned above has been created, and a further increase in material stress has led to its rupture. It ran from the bulge to the barrel's inlet, from the upper part of the barrel, initially towards the outlet, and then turned diagonally downward, then further along the plate on the edge of the bolt hooks, so that the barrel's wall was rolled upward and exposed the inside of the cartridge chamber. Microscopic examination of the separation edges showed a regular structure of fine-grained steel without inclusions or corrosion. At the edge of the rupture near the plate, the yellow hard solder substance, which is usually used to connect the barrel assembly, was visible. The markings on the barrels indicated that the outlet of the damaged barrel was made in the form of a choke. The stamped markings also indicated that the barrels have undergone firing tests and can be used to fire cartridges cal. 12/70 with nitrocellulose powder, generating a standard pressure of 65 MPa, measured by the crush resistance method. A fragment of a wooden settlement piece was torn off on the left side of the action body's lock, similarly to the action body's left eyelet. The forend wood had large cavities and its fitting was bent. With a weapon in such a state it was possible to fire from the right-hand barrel of the shotgun.

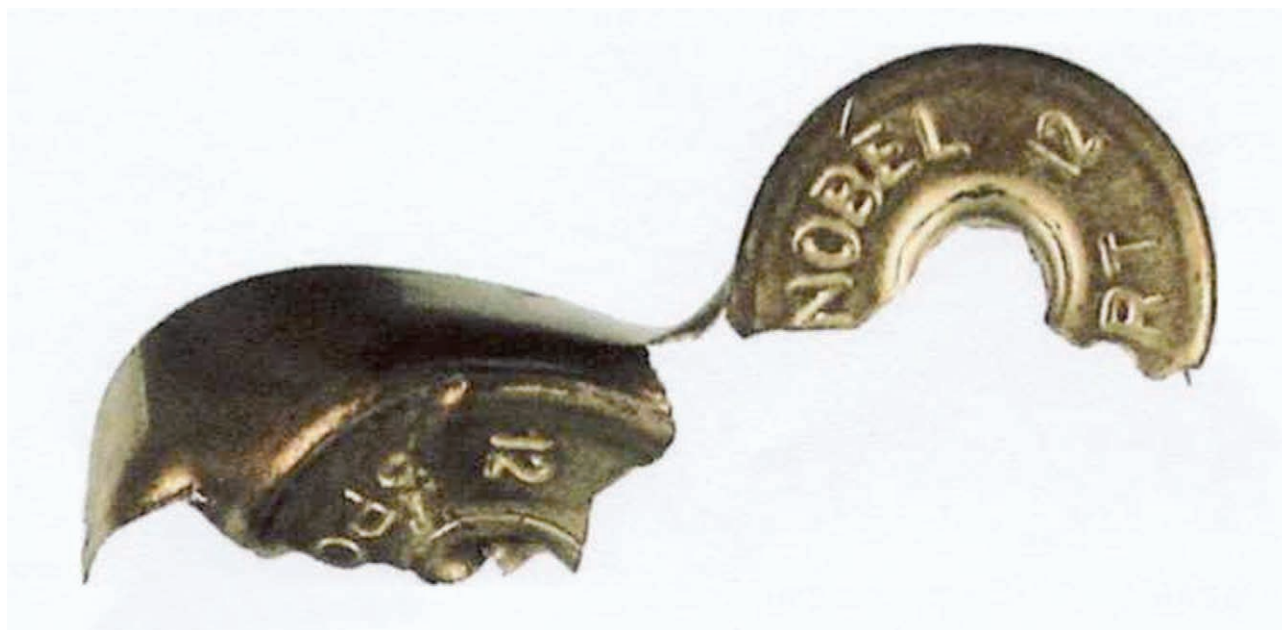
Fig. 2. View of the cartridge rim.

The bent rim of the cartridge cal. 12 has a stamped inscription “NOBEL 12 SPORT 12”, which indicated that the cartridge shell is French-made. The bend of the rim was similar in shape to the bend of the wall of a torn barrel. There was no primer on which the traces of the firing pin and, usually, the best traces of the action body's front part are preserved, allowing for individual weapons identification tests.

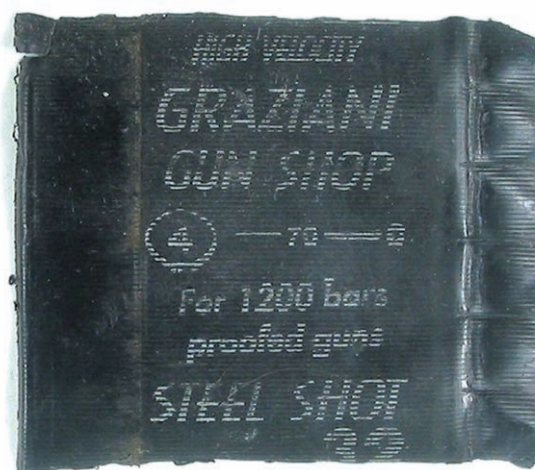
Other type of information could be derived from the inscription on the ruptured body of the cartridge shell cal. 12/70. It indicates that the cartridge originates from a batch produced for a Dutch distributor. The cartridge contained 32 grams of steel shot no. 4, and most importantly, it was designed for weapons withstanding the pressure of 1200 bar (120 MPa), measured with the use of piezoelectric sensor. Embedding traces on the

Fig. 3. View of the cartridge shell body.

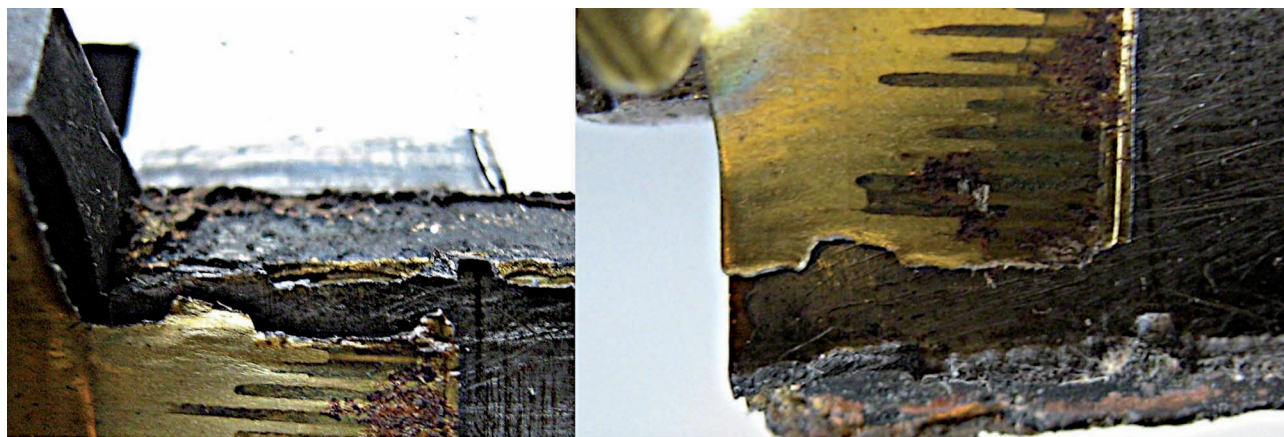
Fig. 4. View of the folded edges of the ruptured cartridge chamber and cartridge shell.

If it is assumed that the submitted cartridge elements were the ones used for shooting and were present inside the cartridge chamber that was ruptured during the shot, the lines of separation of the cartridge chamber, the rim and the cartridge shell should be identical. It is worth reminding here that, during the firing, the cartridge shell is pressed against the inside of the cartridge chamber under the pressure of gunpowder gases. Next, the shell along with the cartridge chamber increase their diameters as a result of the chamber's elastic deformation and the shell's elastic and then plastic deformations. This means that after the pressure drop the chamber returns to its original dimensions, while the diameter of the shell remains increased – however, to the extent that the clearance between the shell and the chamber is maintained, allowing the shell to be removed freely from the chamber. In the case described herein, excessive pressure caused the material of the cartridge chamber to separate, and the resulting gap became a cutting edge for the shell material, as proved by microscopic comparison of the edges. The comparison of the separation line of the rim and the shell body made of plastic was also positive despite the phenomenon of “floating” of soft plastic.
