# Examination of defective mobile devices – a case study

1 Forensic Laboratory of the Provincial Police Headquarters in Szczecin, marcin.napiorkowski@sc.policja.gov.pl

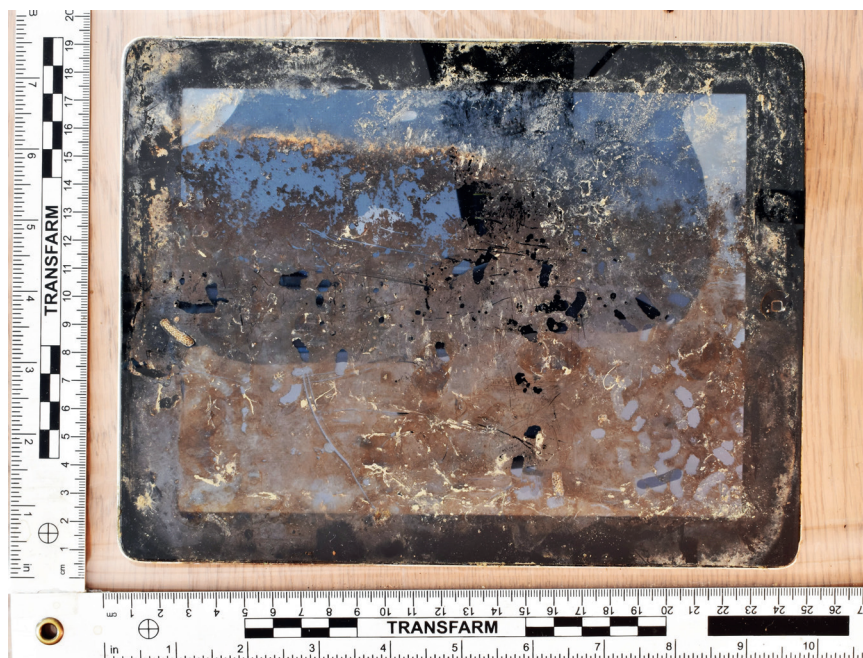
Fig. 3. Tablet, front view.  
Source: own resources

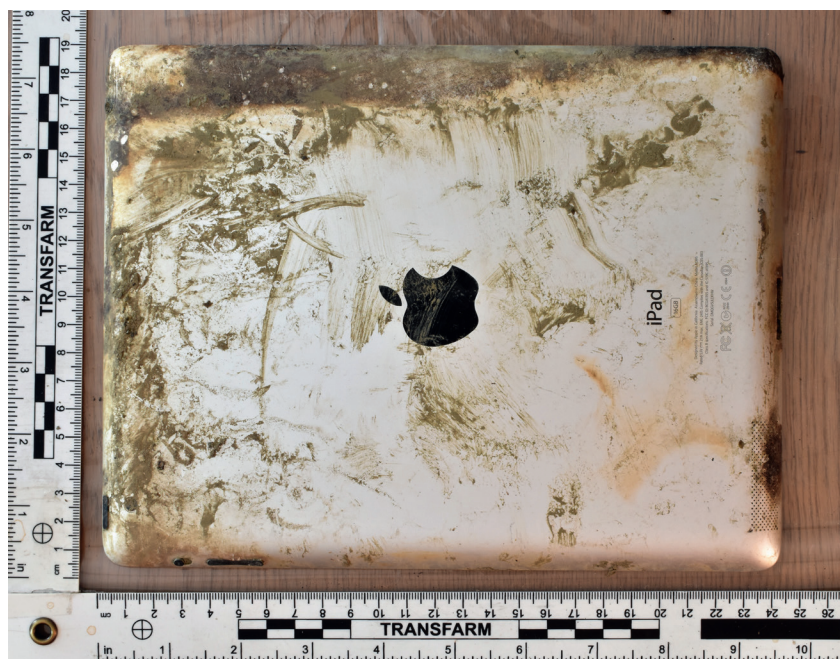
Fig. 4. Tablet, rear view.  
Source: own resources

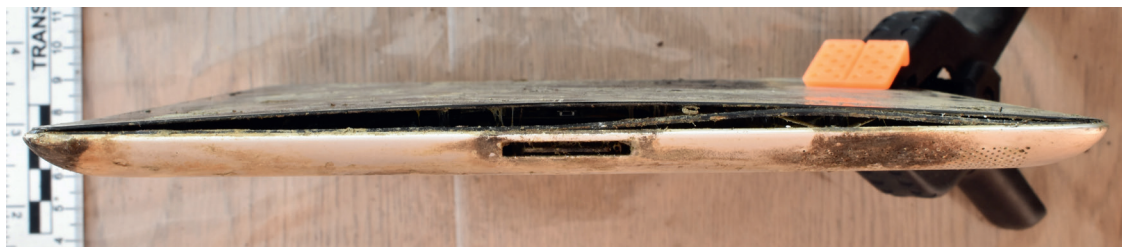
Fig. 5. Tablet, view from the 30-pin connector.  
Source: own resources

A bulge in the screen on the iPad 2 device is noticeable (Fig. 5), caused by a change in battery volume. This is not unusual among faulty lithium-ion cells; it happens as a result of a build-up of gases in the sealed battery pack. This happens, for example, as a result of over-discharge or damage to the controller monitoring the battery status. There were also shielding elements on the motherboards of the devices in the form of special adhesive labels and metal covers that could hinder the drying process, so these were removed (Fig. 10). Loose debris was removed from both device motherboards using a soft brush, a 2% solution of ultrasonic cleaner (Tech-Sonic) and distilled water. The next step could be to thoroughly clean the system in an ultrasonic cleaner, but the Forensic Laboratory of the Provincial Police Headquarters in Szczecin does not have the facilities to accommodate such a large device. A hot air flask with a temperature setting of 100°C and a distance of about 20cm from the system was used for re-drying. In addition, compressed air was used to remove humidity that may have accumulated underneath the large area systems. This method should be used very carefully due to the risk of detachment and loss of damaged components. Visually, no damage was revealed. The main power line was then identified on the motherboard of the iPad 2, where no short circuit to ground was found. An identical device was obtained from the Communications and IT Department of the Provincial Police Headquarters in Szczecin, in which the motherboard was replaced with the one removed from the evidence device. The tablet did not start up despite being powered up. When a switched-off Apple phone or tablet is connected to a power source, it automatically starts up. For this reason, a thorough inspection of the motherboard was carried out using a microscope and, for example, only the connector area (J2201) showed the destructive effects of water, with oxidation of the pathway at the contact points between the tin and the copper field. It is possible to bridge the connections thanks to diagrams of the motherboard available on the Internet. Another method of fixing this defect is to scrape the protective mask off the surface of the pathway and extend it. Due to the lack of a precision soldering iron at the Forensic Laboratory of the Provincial Police Headquarters in Szczecin, this defect cannot be fixed, the attempt to read the data failed.

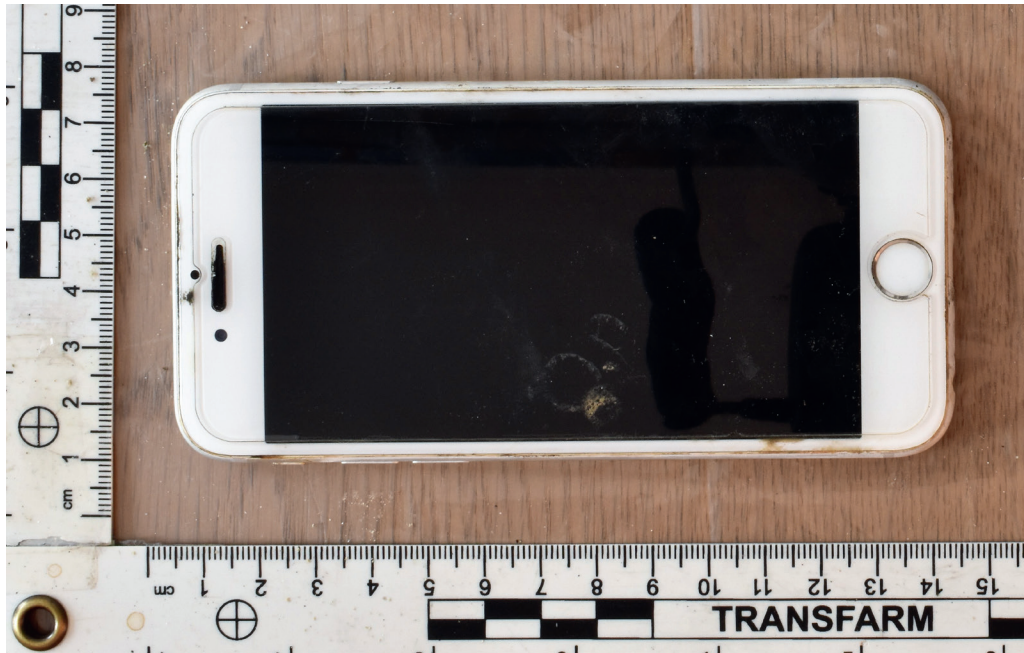
Fig. 6. Phone, front view.

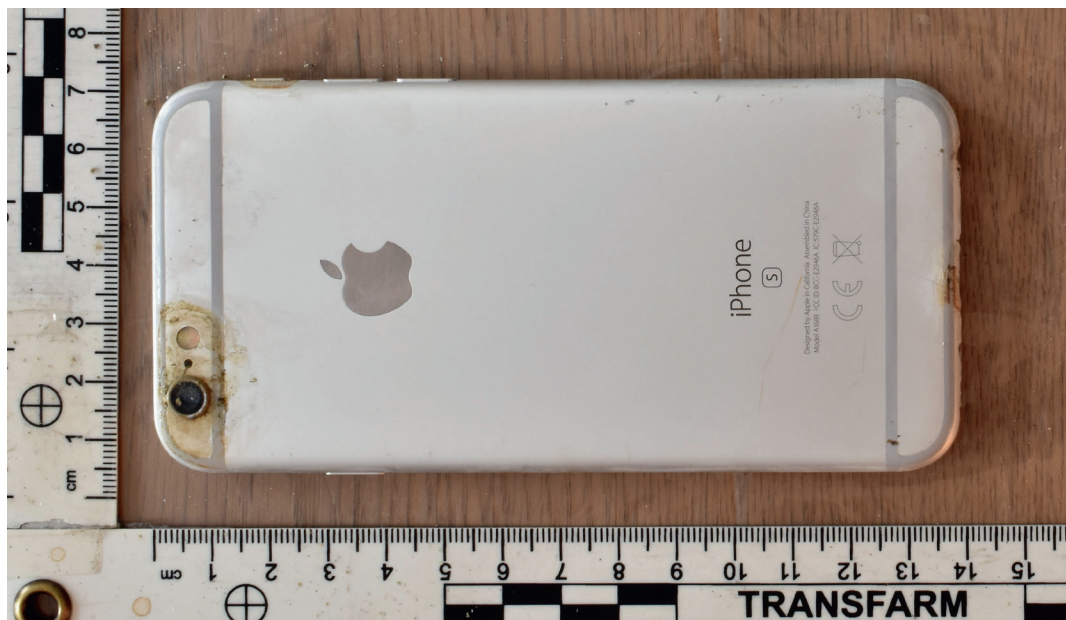
Fig. 7. Phone, rear view.

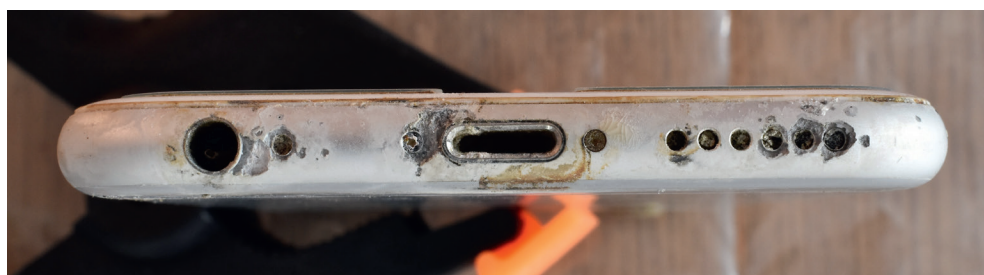
Fig. 8. Phone, view from the Lightning-type connector.

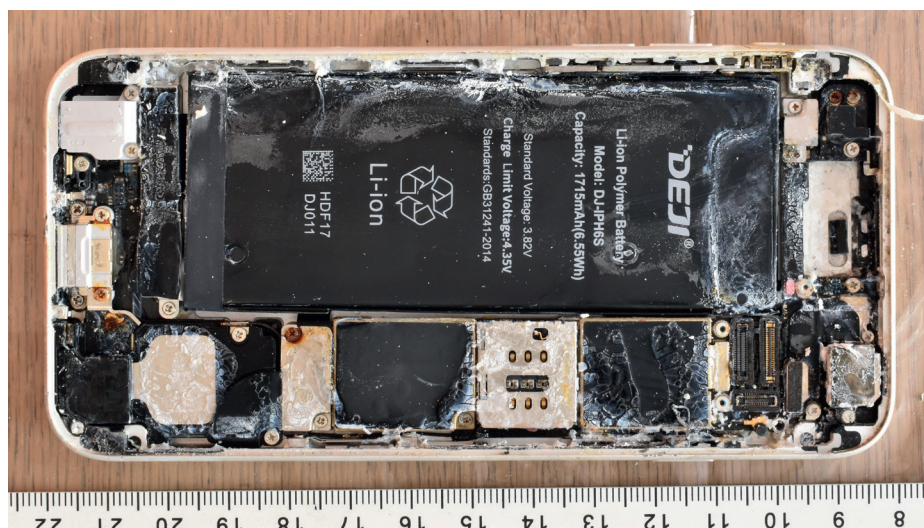
began by unpacking the material (Fig. 1 and 2), photographically recording their physical condition (Fig. 3-8), cleaning them of loose debris and drying them at room temperature in an airy and dry room. The drying process began by disassembling the devices (Fig. 9), disconnecting the batteries and removing the key components, the motherboard containing the memory media.

Fig. 9. View of the inside of the phone.

The examination of the iPhone motherboard followed the same procedure as that used for the iPad. Shielding elements were removed, and loose debris was removed with a soft brush and solution. An ultrasonic cleaner with a solution of the concentration as above was used for the purpose of thoroughly cleaning the motherboard, the operating time was set at three minutes. Visually, no damage was revealed. The main power line was identified on the motherboard, where no short circuit to ground was found. The Communications and IT Department of the Provincial Police Headquarters in Szczecin could not supply an identical device, so the so-called donor was obtained from external sources, but with a faulty button under the Home Button screen. The motherboard was replaced with the one removed from the evidence device, connected to power and the phone booted up. At this stage the problem I mentioned in the introduction occurred, the phone prompted for a user PIN code, which is unknown. The data on the phone is secured against unauthorised access by a six-digit PIN, which results in 1,000,000 possible combinations. The iPhone 6S features the Apple 9 processor, which is susceptible to a dictionary attack that can be performed using specialised software in the DFU (Device Firmware Upgrade) mode. Putting the phone into DFU mode requires the use of physical buttons, the side buttons and the Home Button below the screen (which in the replacement device is defective). The design of the phone's front panel is made up of three basic components, i.e. the display, the digitizer (the component responsible for detecting touch on the screen) and the Home Button. Each of these is connected to the motherboard via a separate cable with a plug, so it is possible to use the Home Button located on the evidence screen (Fig. 11). In this configuration, the phone was put into DFU mode and the procedure for breaking the security measure applied was initiated. This activity took place on the phone at a rate of approximately six passwords per minute. After only 17 hours, the correct PIN was revealed, allowing data extraction in FFS (Full File System) and Checkm8 modes.
